CORNER RECORD

City of Rocklin County of Placer, California
Brief Legal Description Radius point at centerline of Elmwood Court, L Maps 92

BOOK 20 CORNER RECORDS, PAGE 80

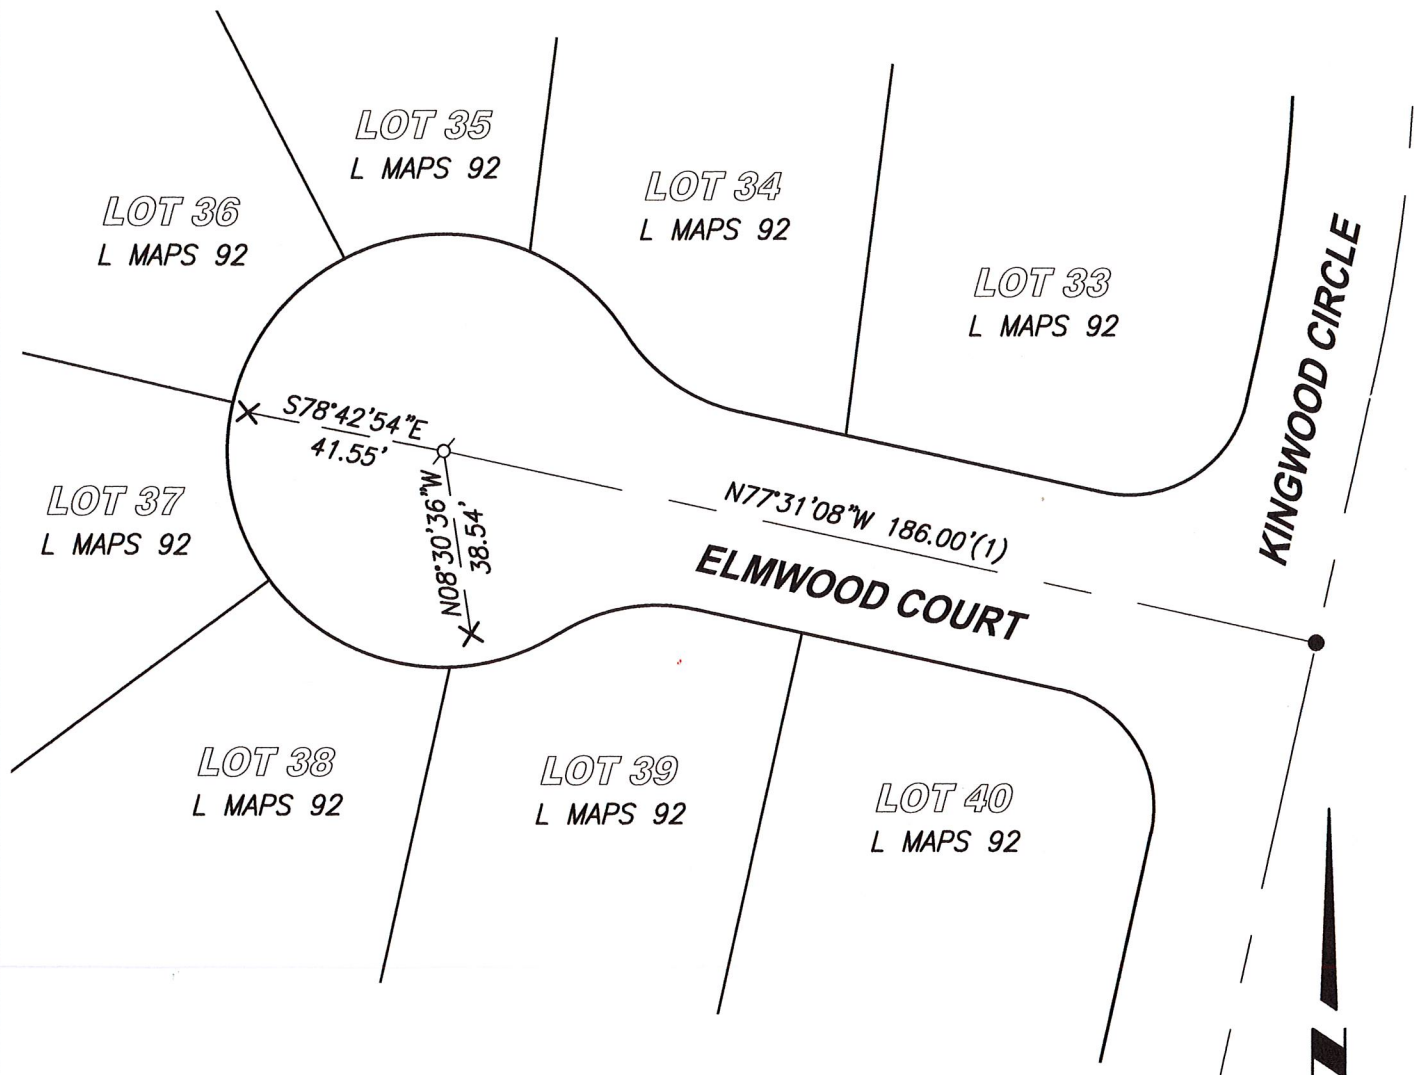
SHEET: 2 OF 2

Corner/
Monument: ☐ Left as found ☐ Established ☐ Rebuilt ☐ Pre-Construction
☐ Found and tagged ☒ Reestablished ☐ Referenced ☒ Post-Construction

- X - - - SET CUT CROSS IN SIDEWALK AS REFERENCE POINT
- O - - - FOUND $\frac{3}{4}$ " IRON PIPE WITH DILAPIDATED PLASTIC CAP (1);
AFTER RE-PAVING SET RAILROAD SPIKE "LS 6947"
- - - - FOUND $\frac{3}{4}$ " IRON PIPE WITH DILAPIDATED PLASTIC CAP (1)
- (1) - - - RECORD DATA PER L MAPS 92
